Bush River 115kV Crossing Rebuild

Tiffany Matthews-Lay & Kevin Elveton Project Management

Proposed Bush River Project

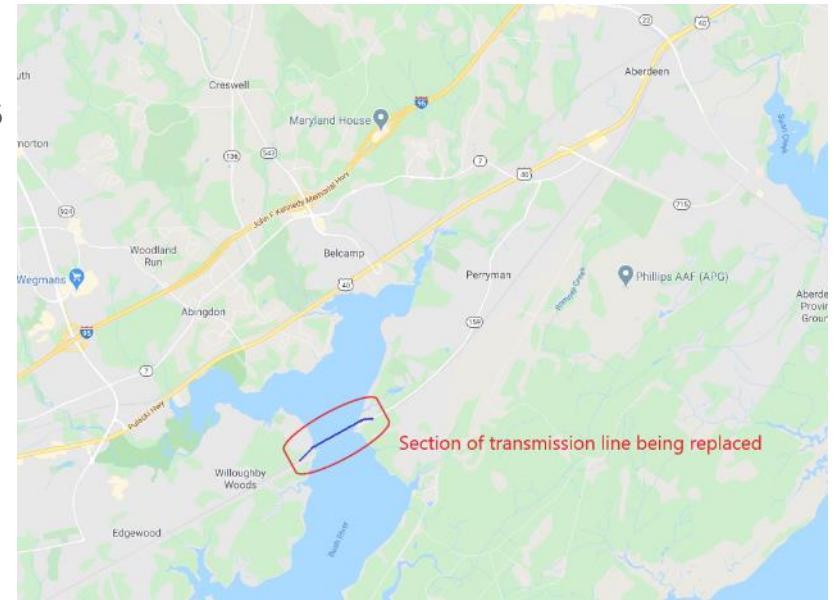
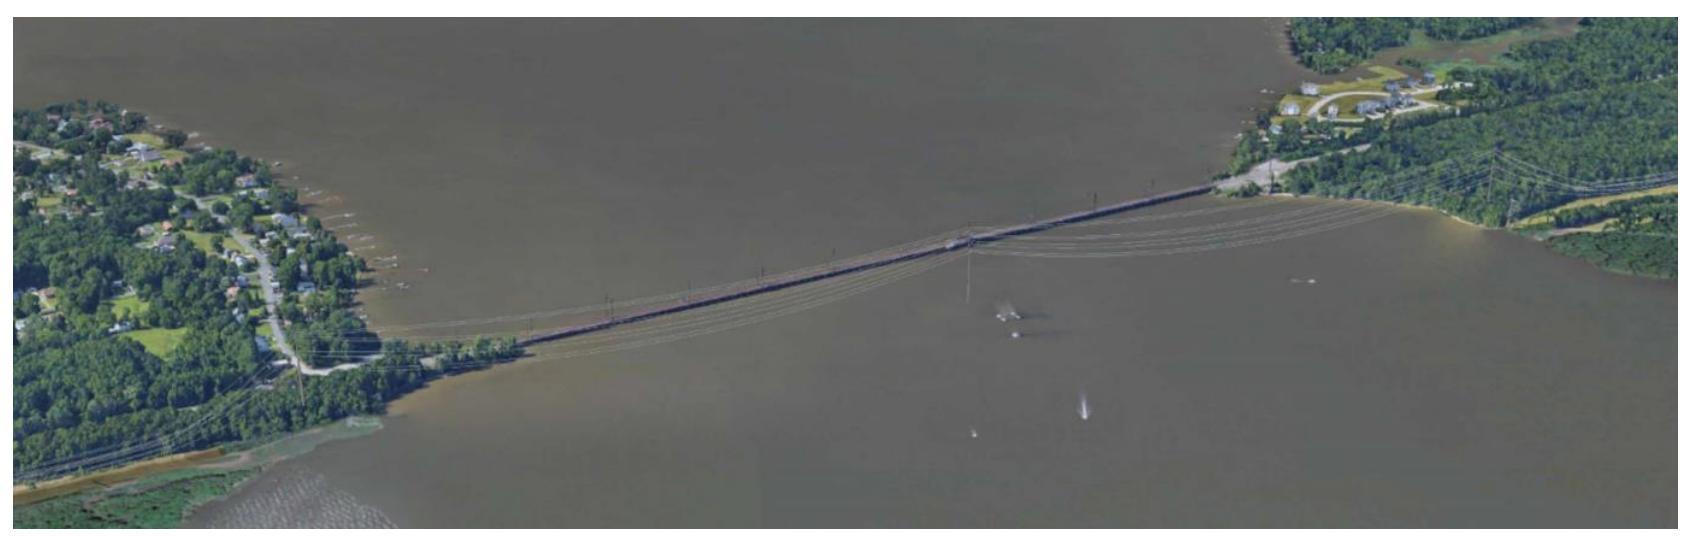
- Rebuild the Bush River Crossing
 - Remove 7 existing "lattice" structures
 - Install 9 new mono-pole structures and foundations
 - One structure located in Bush River
 - New conductor
 - 1.1 miles long
 - Additional easements required
 - Construction starts September 2021

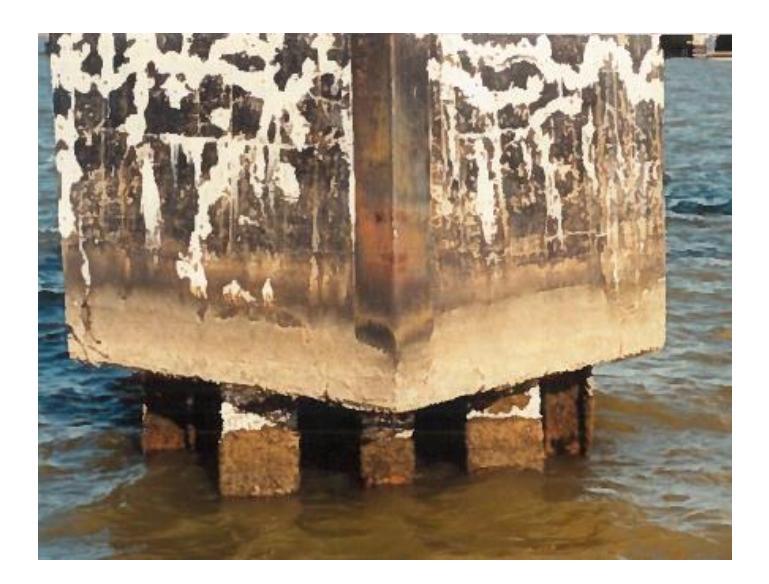
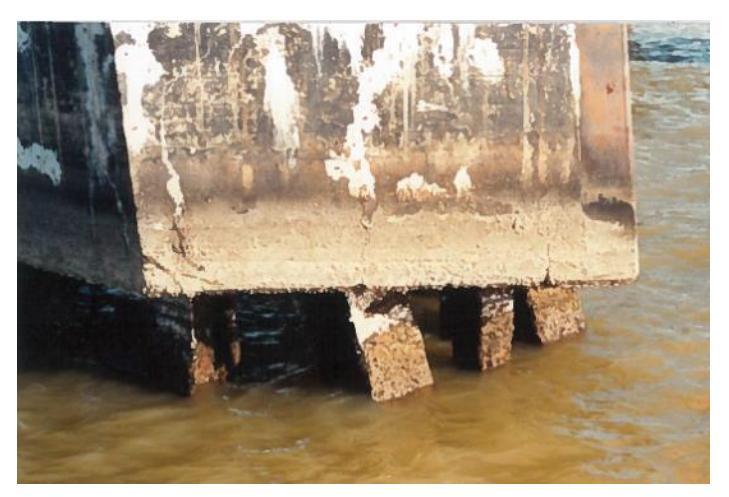
Structural Reliability and Safety

- In 1991, these tower foundations were inspected and severe degradation was discovered
- Repairs were made in 1991 by
 - Installing cofferdams
 - Splinting the pipes back together using new steel and grout
 - Encapsulating the piles
- The encapsulation prevents further inspection of the steel piles
- Project reports indicate an expected 25year life span for the repairs – currently in year 29

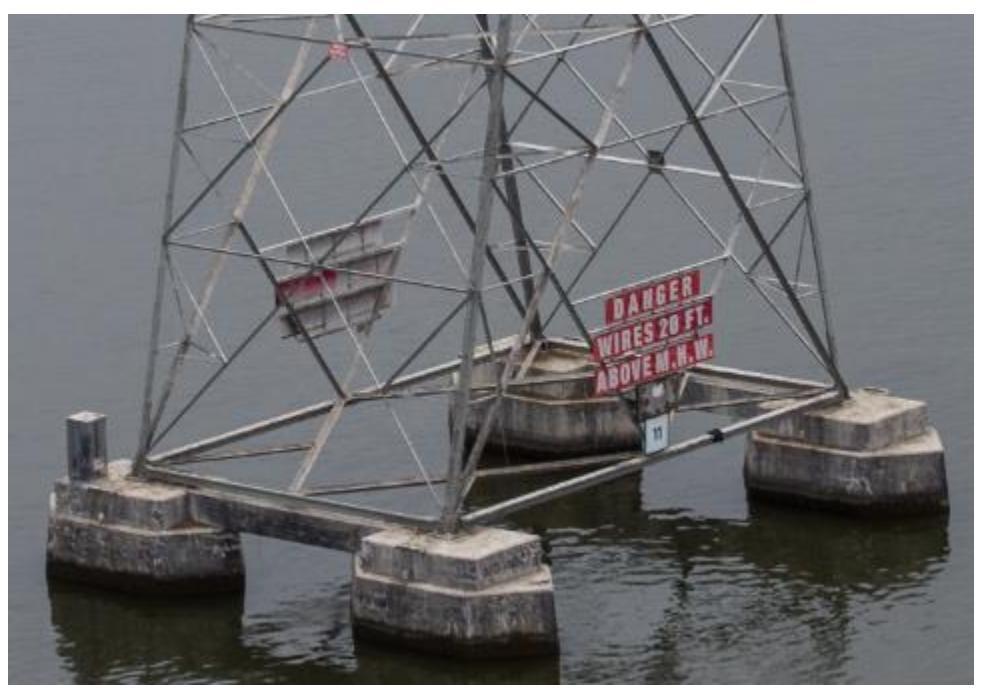
Boat Safety

- Lower clearance in existing line
- The line has had a history of sailboat contacts
 - An incident In the late 1960s
 - In June 2000, a sailboat slipped from its mooring and contacted the lines, causing an outage and the total loss of the vessel (no one was on board)
 - In August 2002, another sailboat drifted into the lines

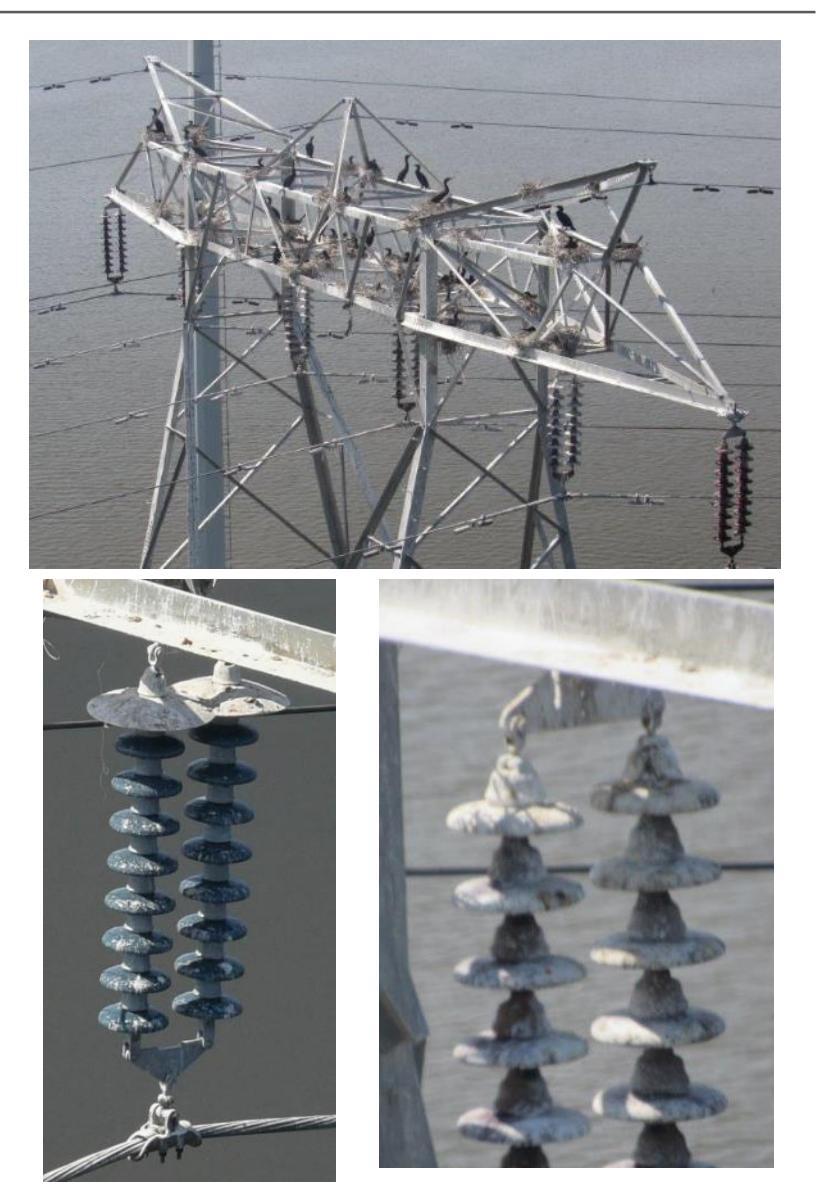
Avian Challenges

- 9 outages (2009-2019) were line-initiated, all 9 occurred within the Bush River Crossing
 - 8 outages were avian interference
 - 7 outages involved bird nest debris
 - 1 outages bird droppings
 - 1 unknown outage
- Momentary outage on 5/10/2017 led to the discovery of a LARGE colony of cormorants
 - Numerous nests
 - Significant contamination found on the insulators, conductors, tower steel, and foundations
 - According to the USDA-APHIS, there are no totally effective ways to keep the cormorants from inhabiting the tower

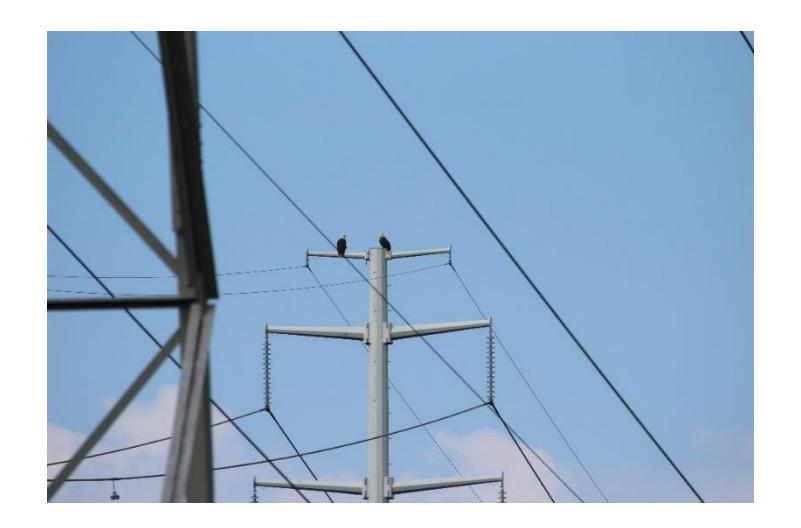
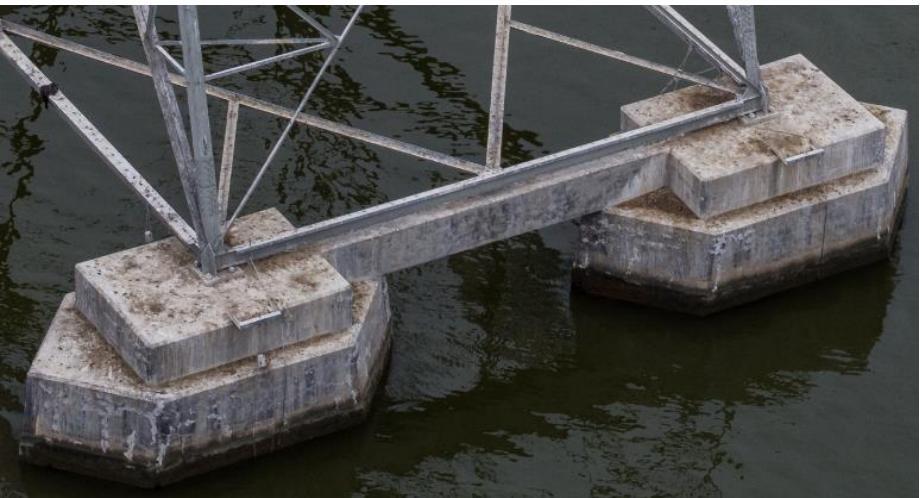
Avian Challenges (cont.)

- During the inspection, an active osprey nest was also found on tower 56 (Perryman side)
- Insulators were replaced and "guano shields" were installed, but due to the liquid state of the contaminant and the steady wind, the shields were not entirely effective
- Coexisting with cormorants means accessing a severely "contaminated" tower, maneuvering around mildly aggressive birds, and maintaining insulators and conductors that will continue to become contaminated

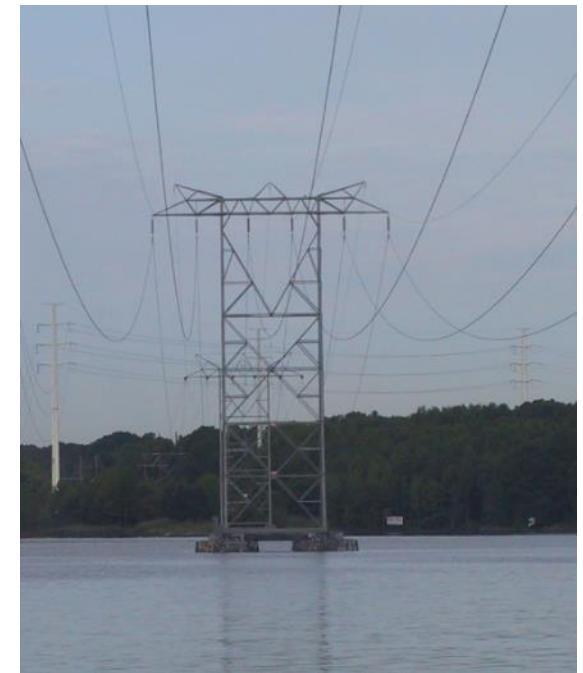
Existing Edgewood to Perryman Transmission Lines

- Built in 1951 to support the APG load after WWII
 - 6.59 miles from Edgewood to Perryman
 - Two single circuit wood pole H-frame lines
 - Short sections of double circuit lattice towers, including the Bush River crossing
- The Existing Bush River crossing
 - Two spans supported by three double circuit (horizontally-configured) lattice towers
 - The two spans are approximately 2000 ft each
 - The middle tower is located in the middle of Bush River
 - Pile and cap foundations
 - Existing structures range in height from 110-115'

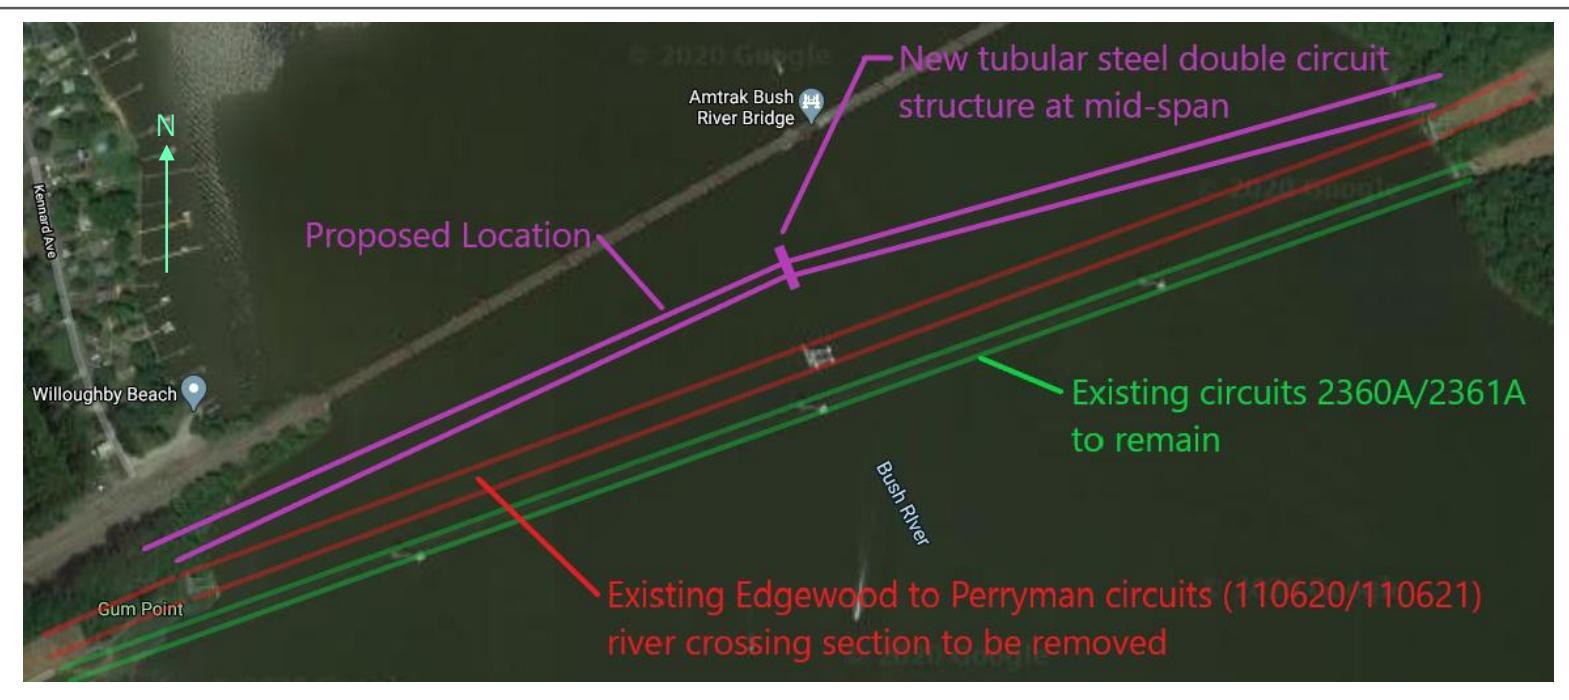
Proposed Solution

- Three double circuit steel lattice towers (one on each shore and one located within Bush River)
- Four single circuit wood Hframes (two on each side of the river)
- Existing conductor (4 spans total)

- 4 new single circuit structures at each bank,
- 1 double circuit structure at mid-span in Bush River on pile foundation
- New section will be built parallel to the existing line to minimize outage impacts
- Design clearance of 49.1 ft (40 ft safe vessel height)

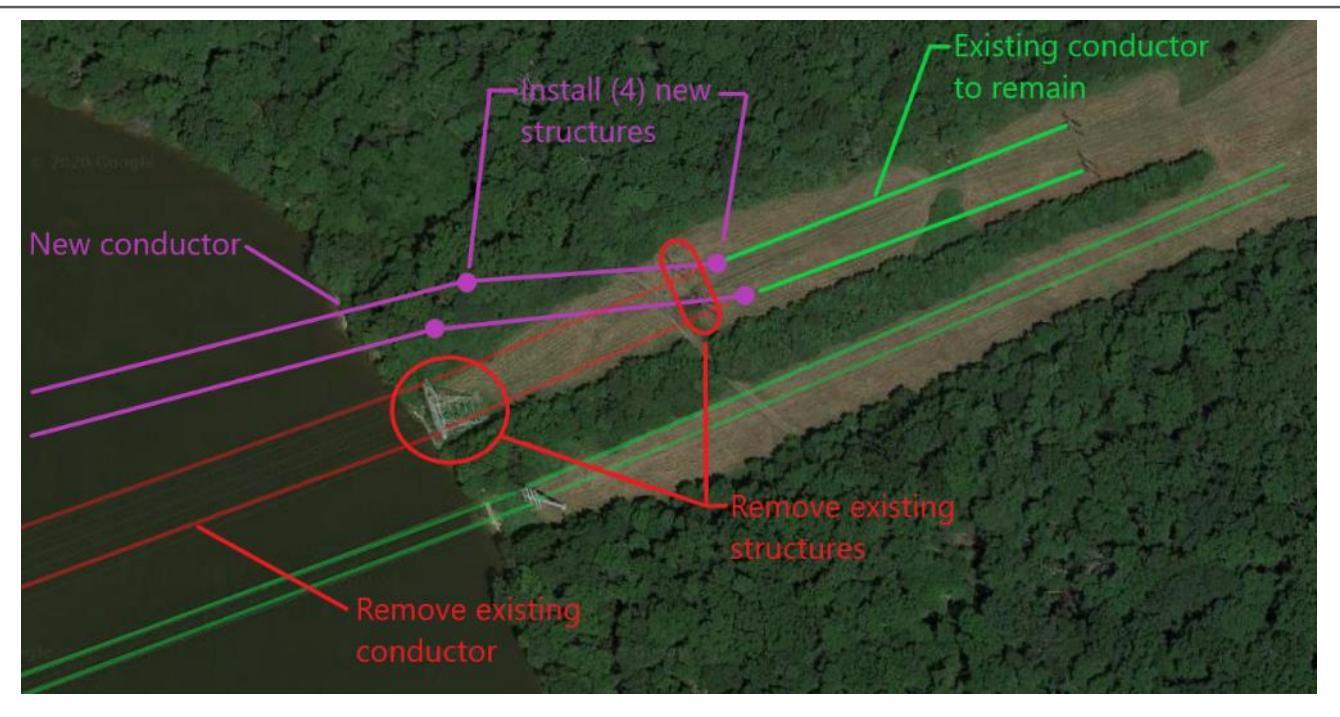
Proposed Solution – Each Bank

- Three double circuit steel lattice towers (one on each shore and one located within Bush River)
- Four single circuit wood Hframes (two on each side of the river)
- Existing conductor (4 spans total)

- 4 new single circuit structures at each bank
- New conductor (4 spans)
- Caisson foundations on land
- Pole caps will be used to deter birds from nesting on structures
